# NORTHRIDGE EARTHQUAKE: LIFELINE PERFORMANCE AND POST-EARTHQUAKE RESPONSE

Technical Council on  
Lifeline Earthquake Engineering,  
American Society of Civil Engineers

Edited by Anshel J. Schiff

April 1997

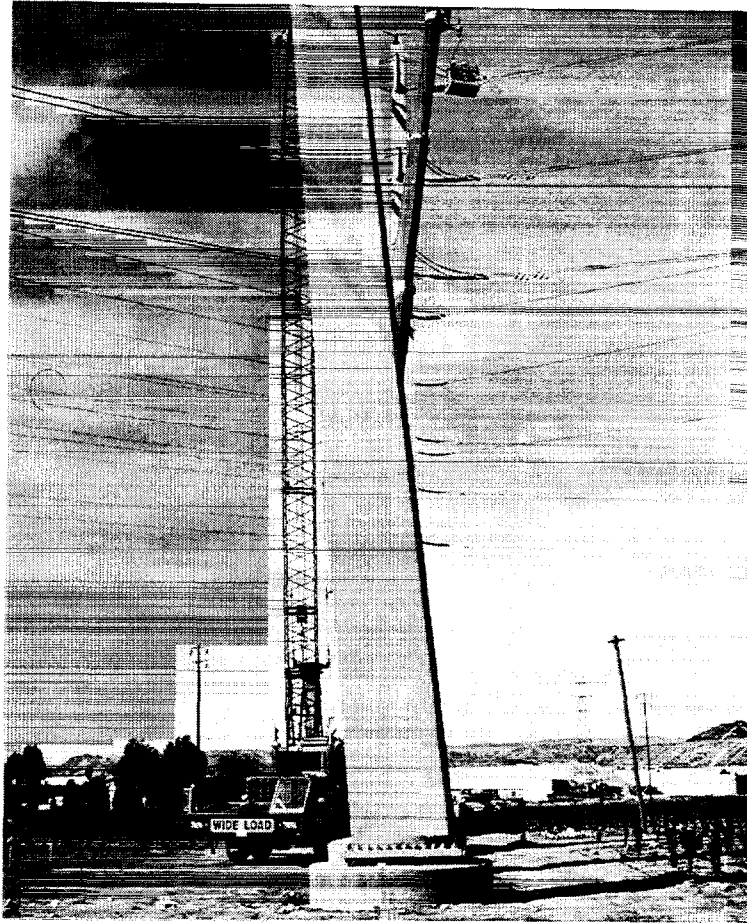
Fig. 3.44 Dead-end transmission tower tipped due to liquefaction and crack in tower.

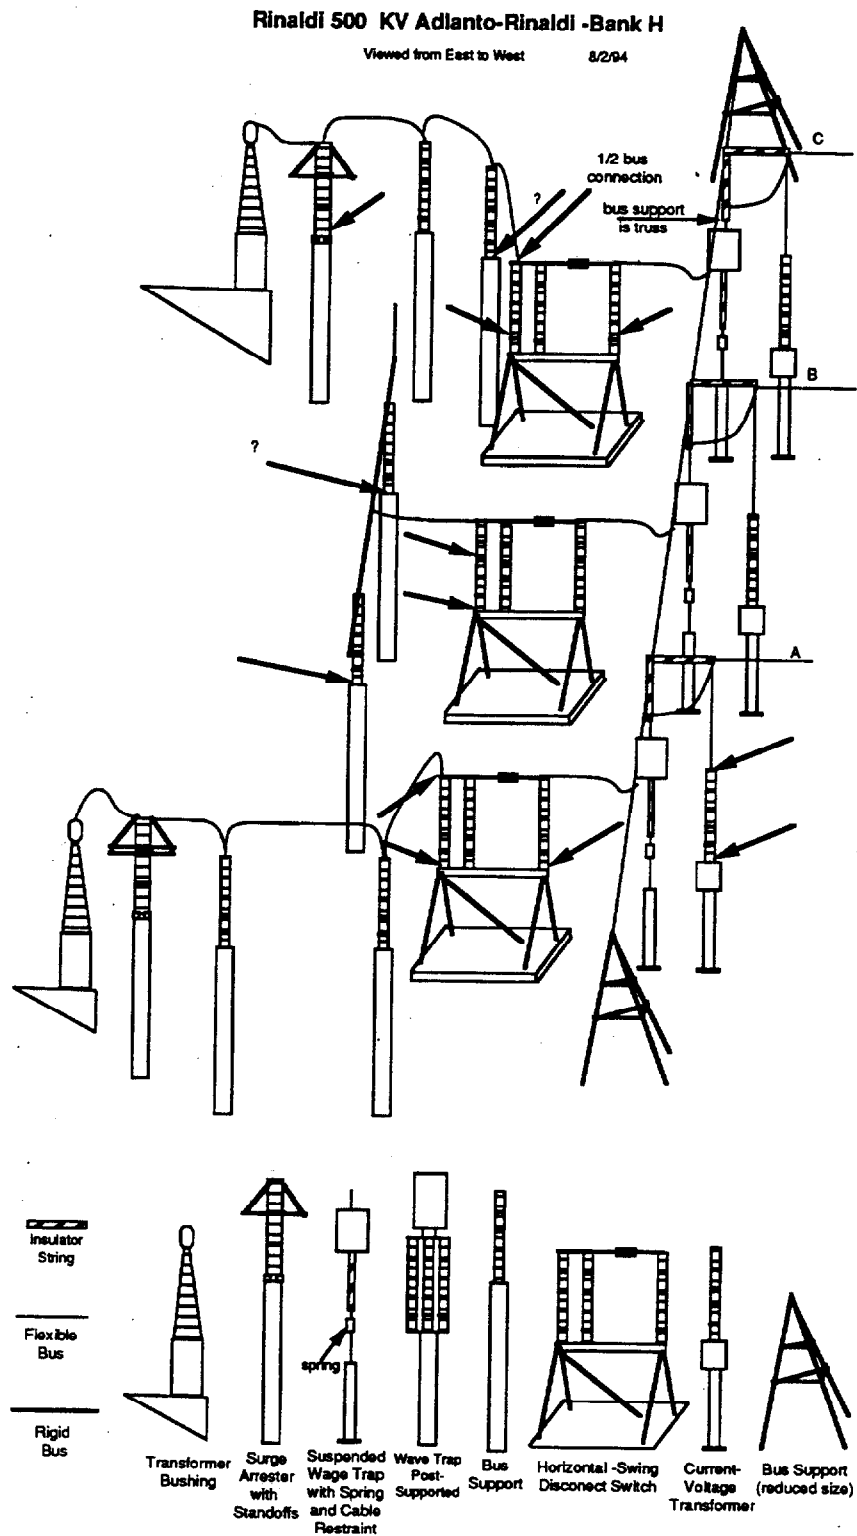
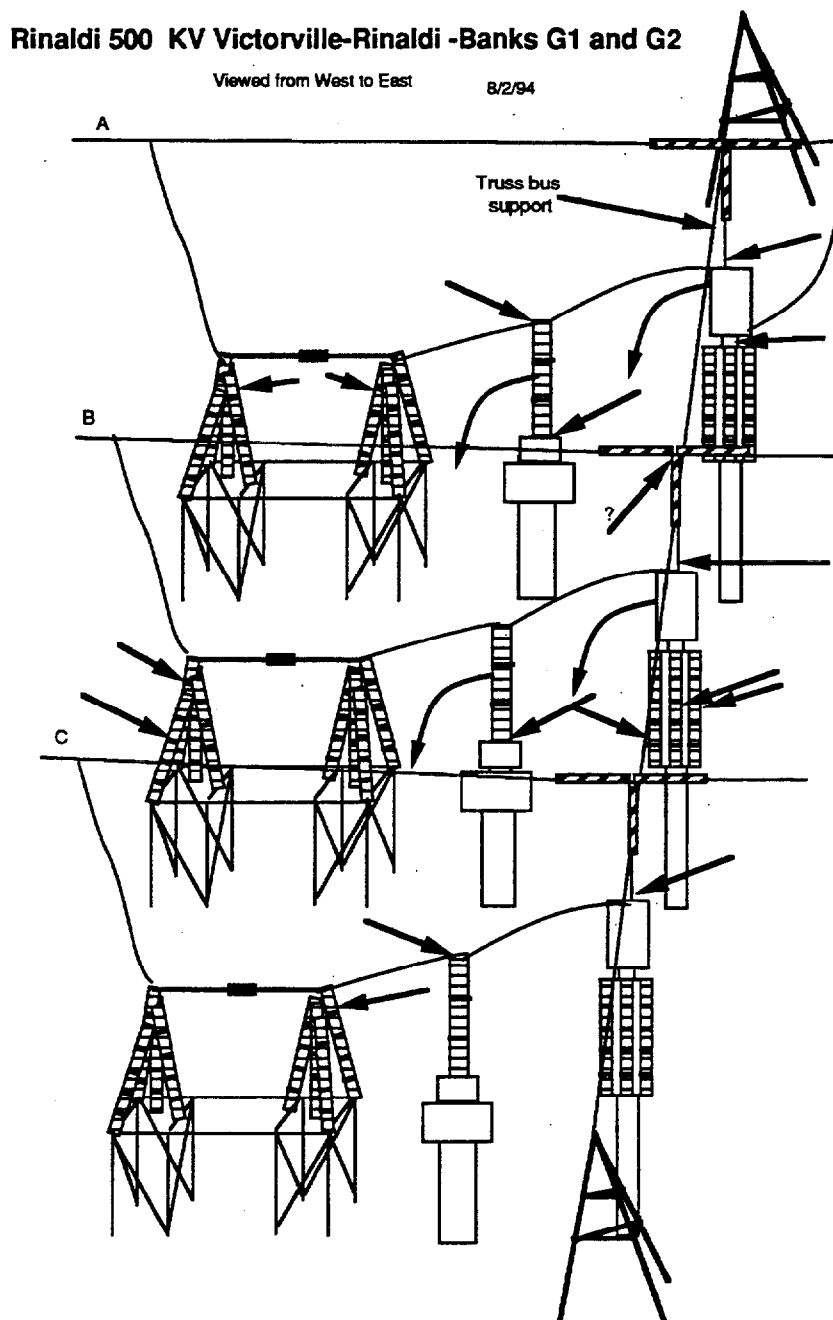
Fig. 3.51 Schematic diagram showing damage to 500 kV switchyard at Rinaldi Substation - Part 1. Note that arrows indicate damage locations.

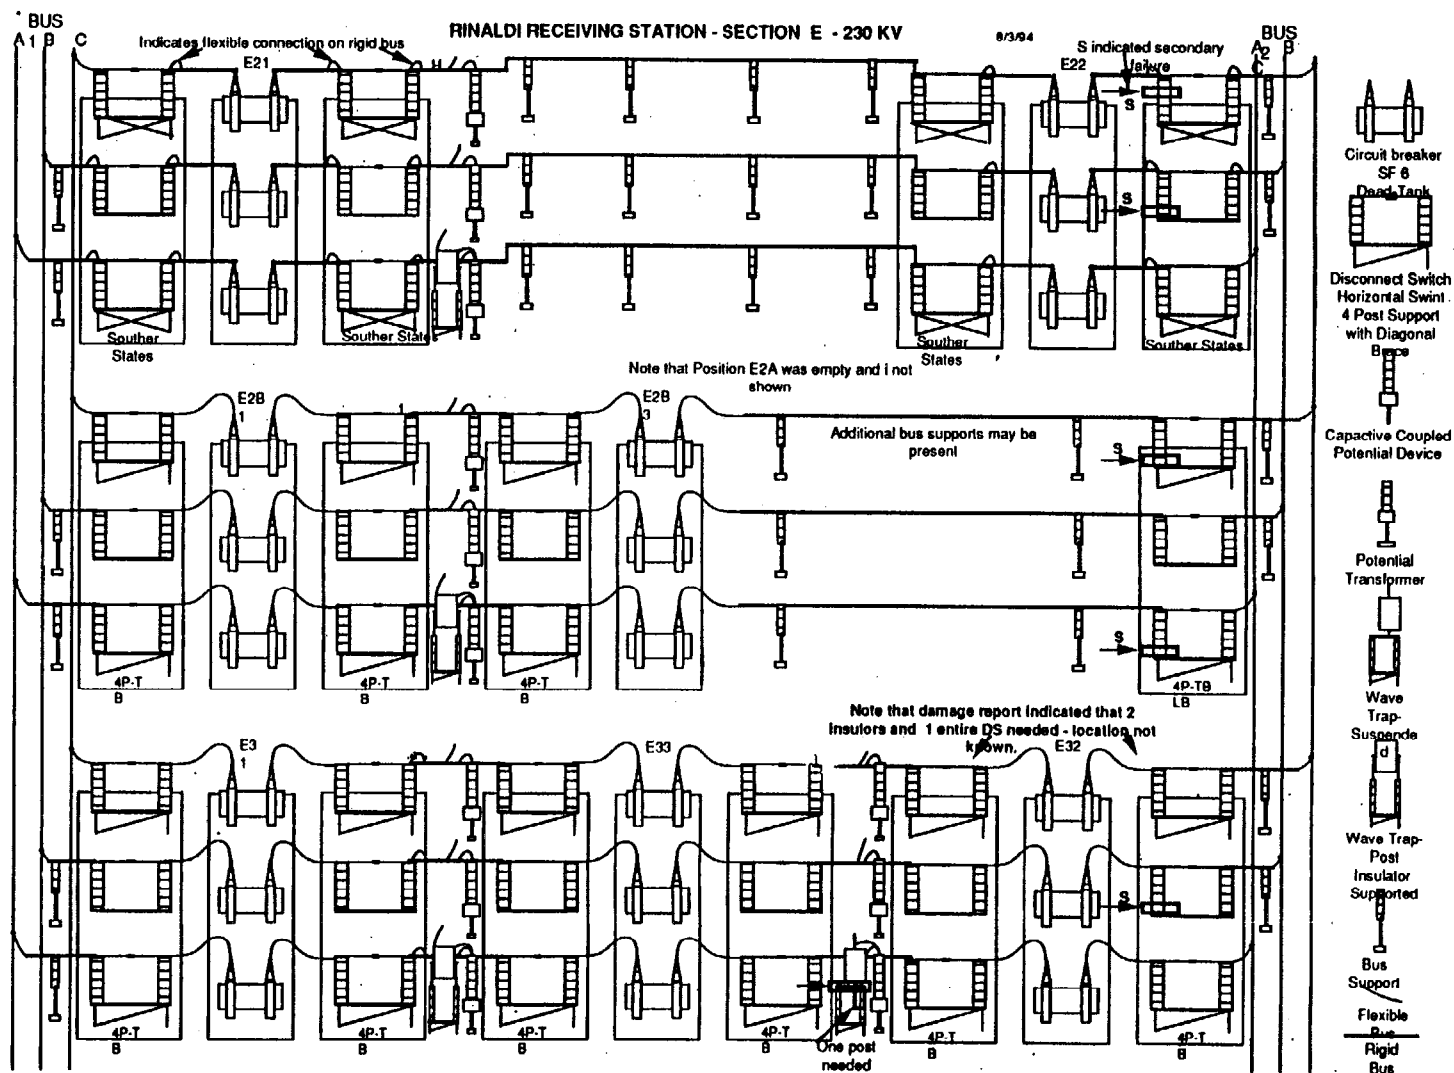
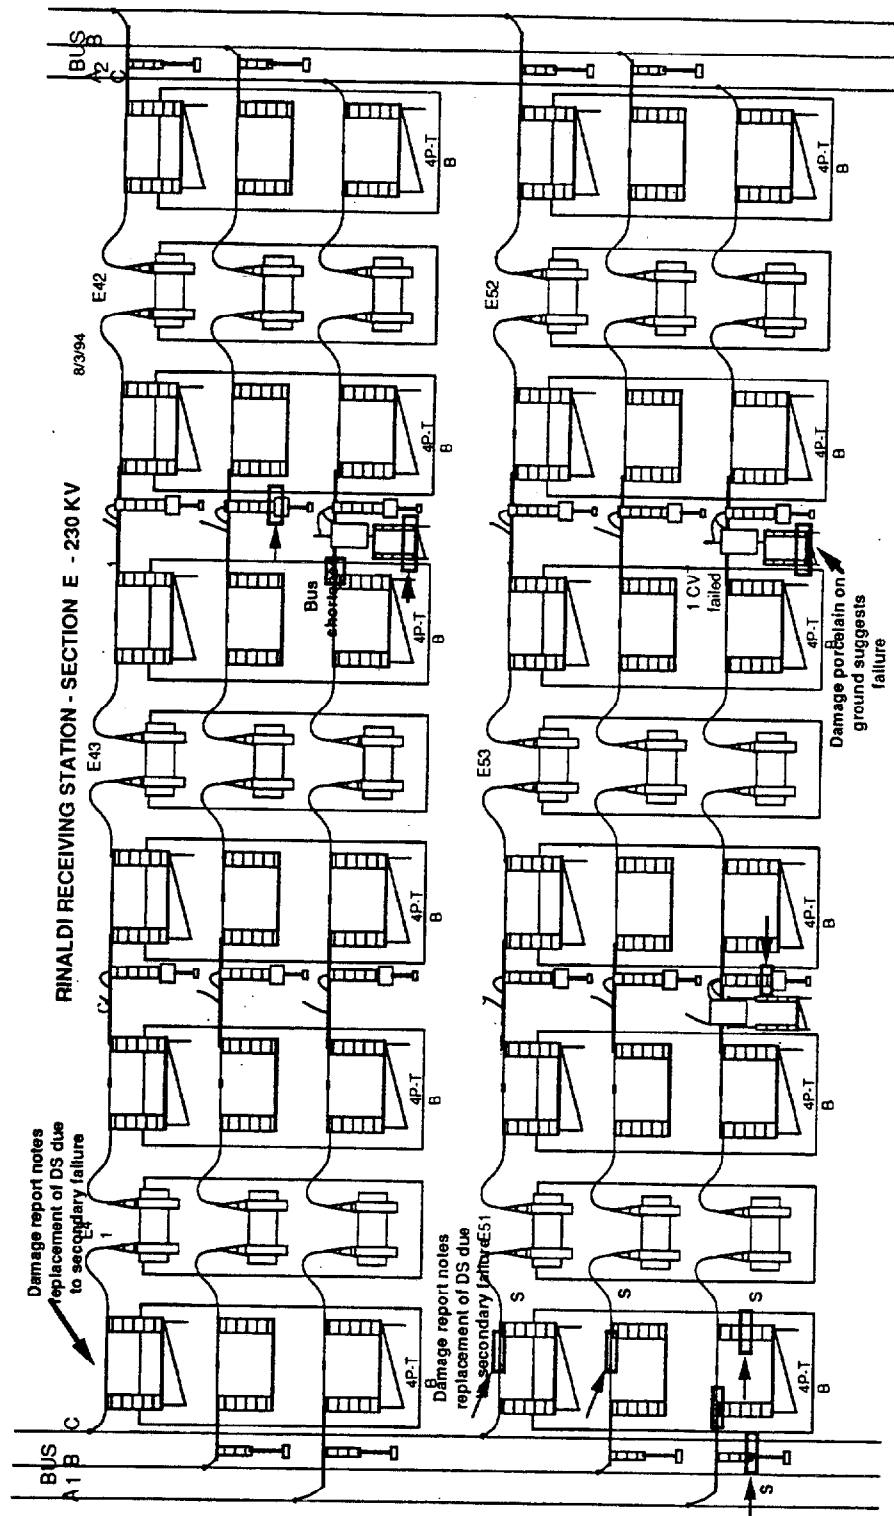
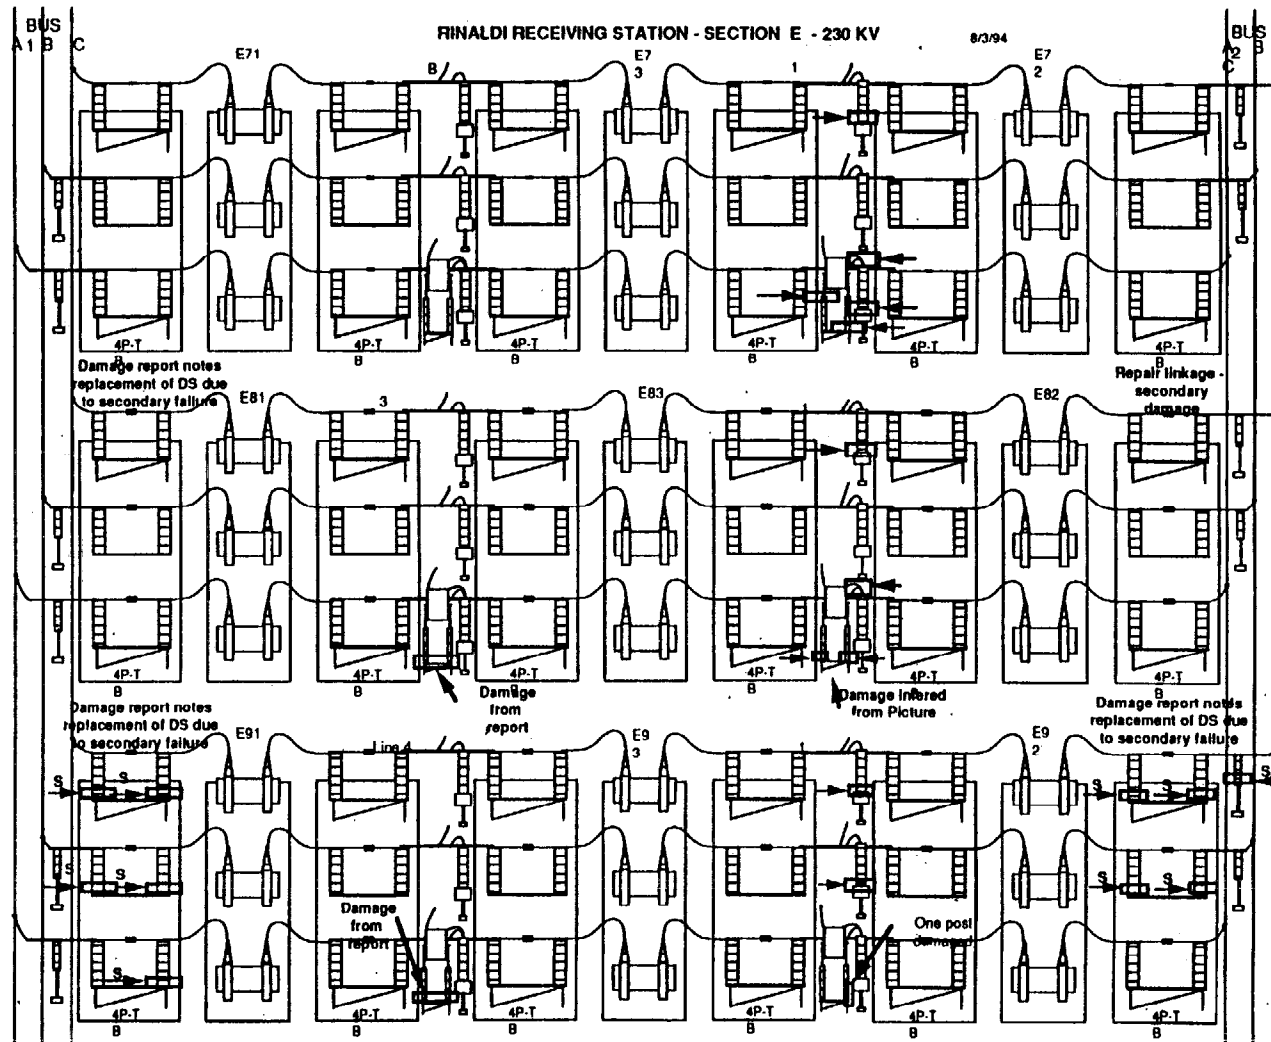
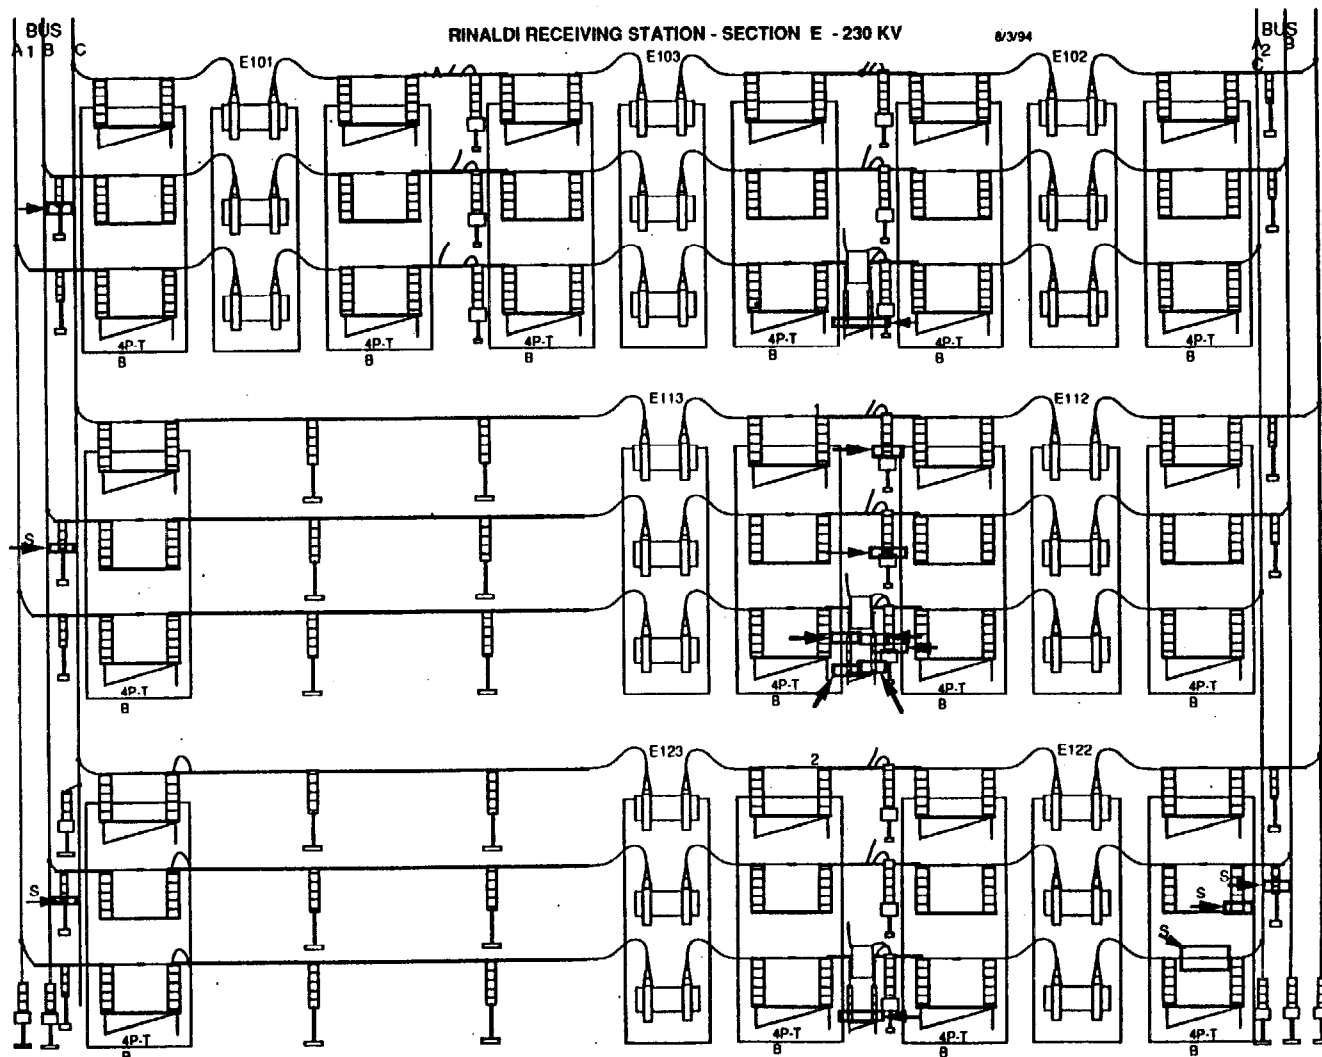
Fig. 3.52 Schematic diagram showing damage to 230 kV switchyard at Rinaldi Substation - Part 1. Note that boxes and arrows indicate damage locations.

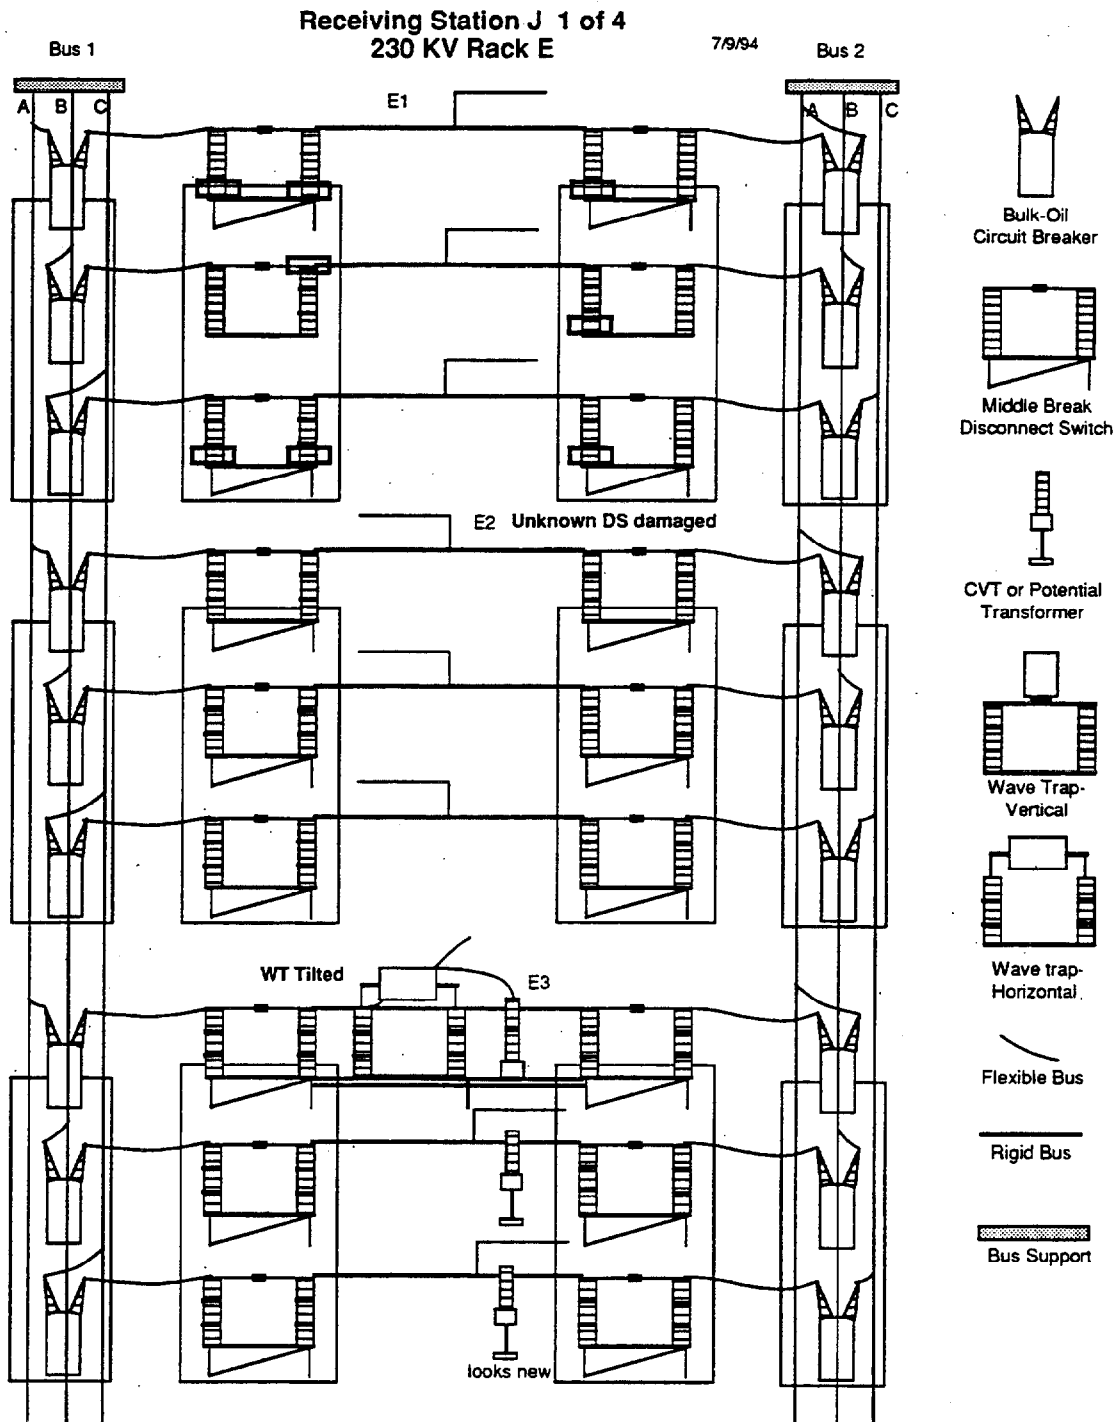
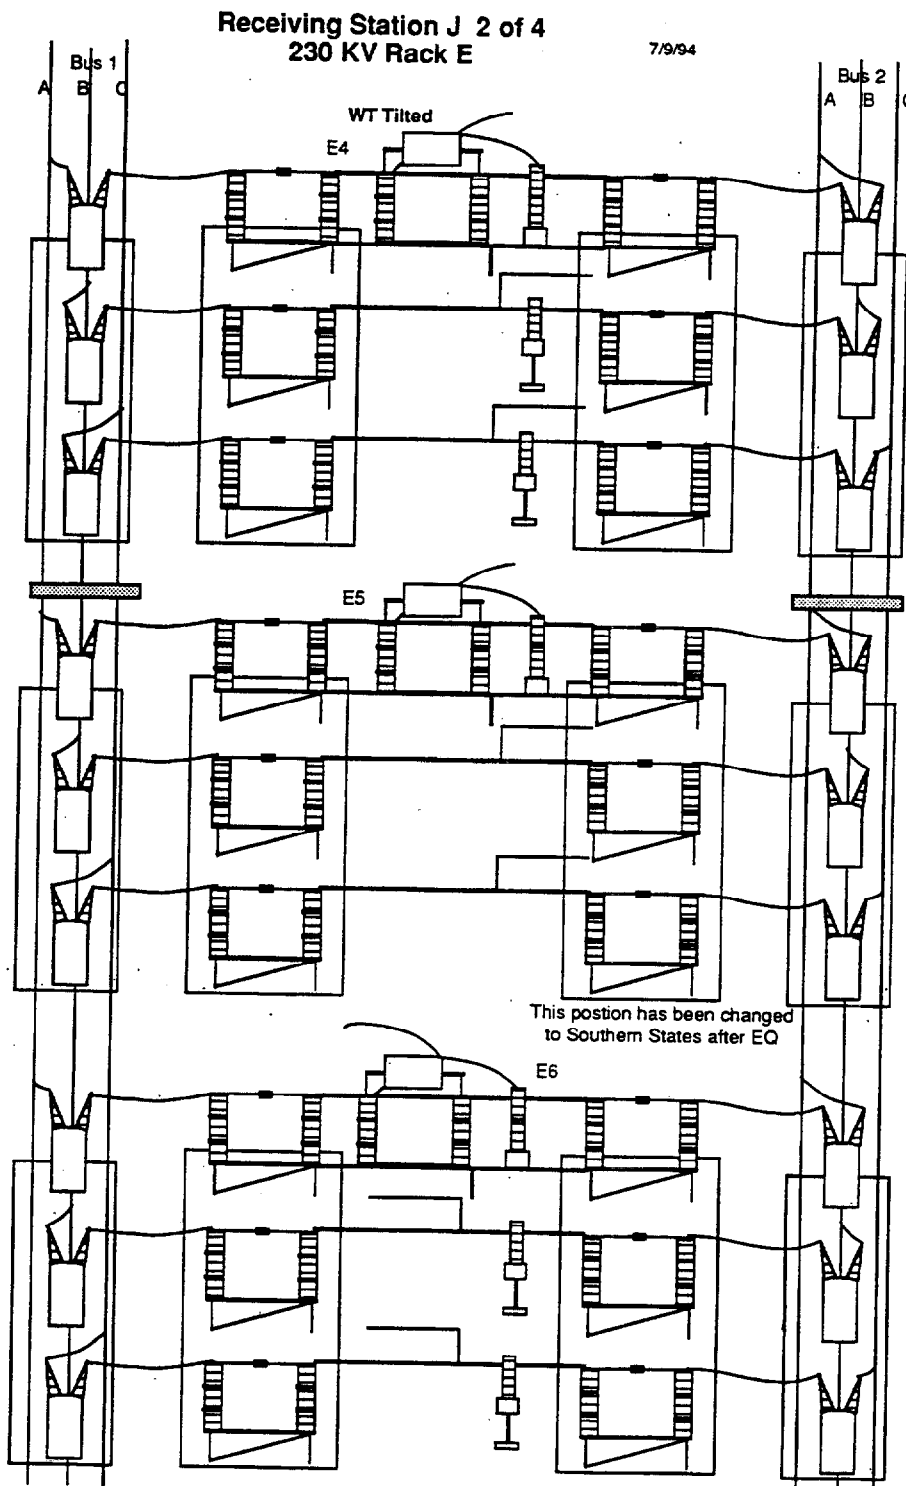
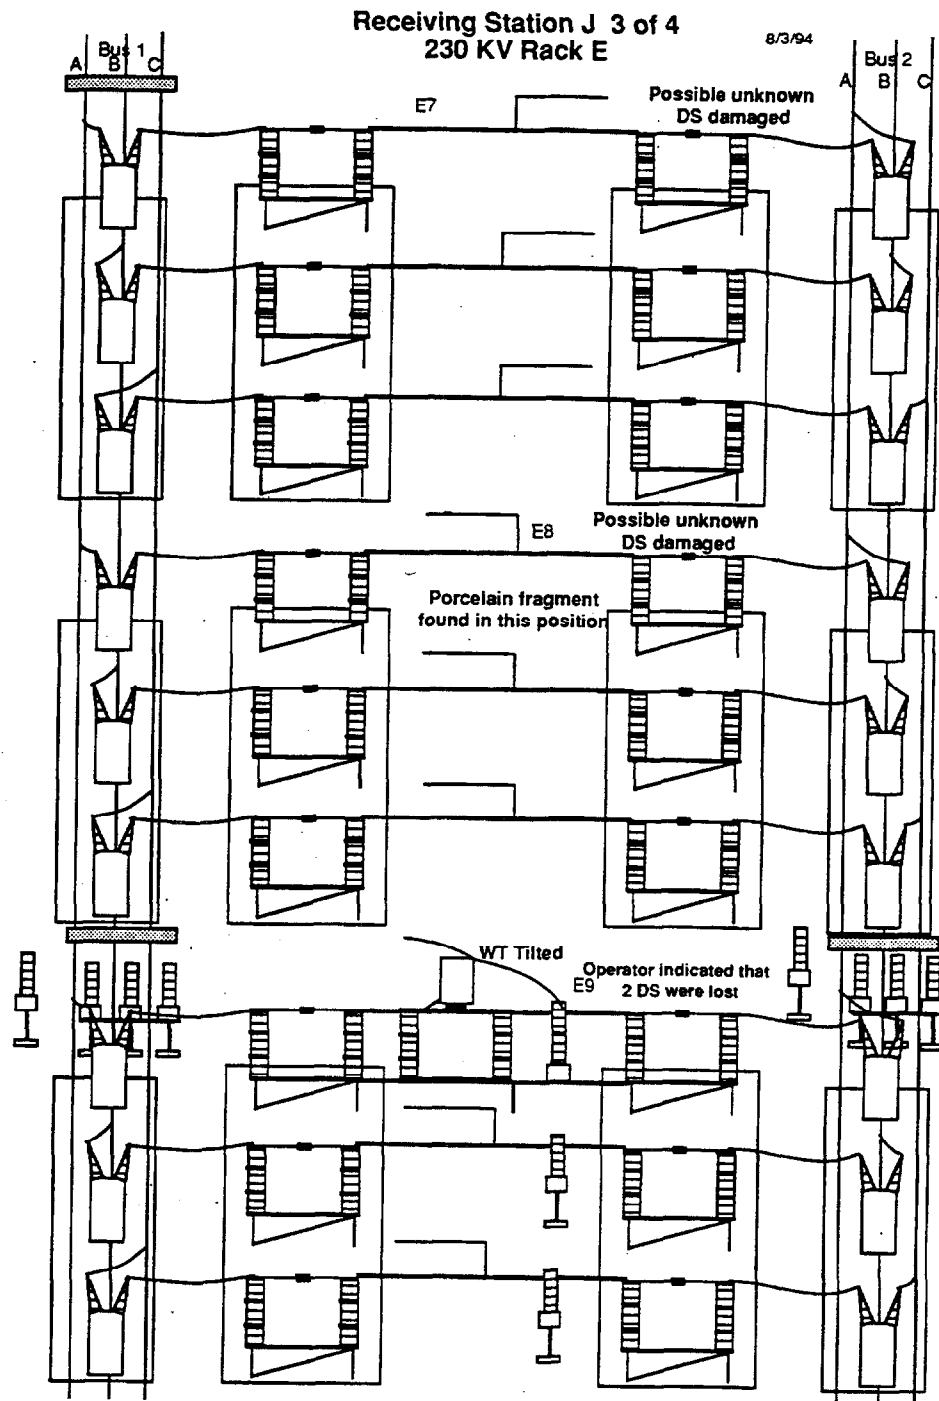
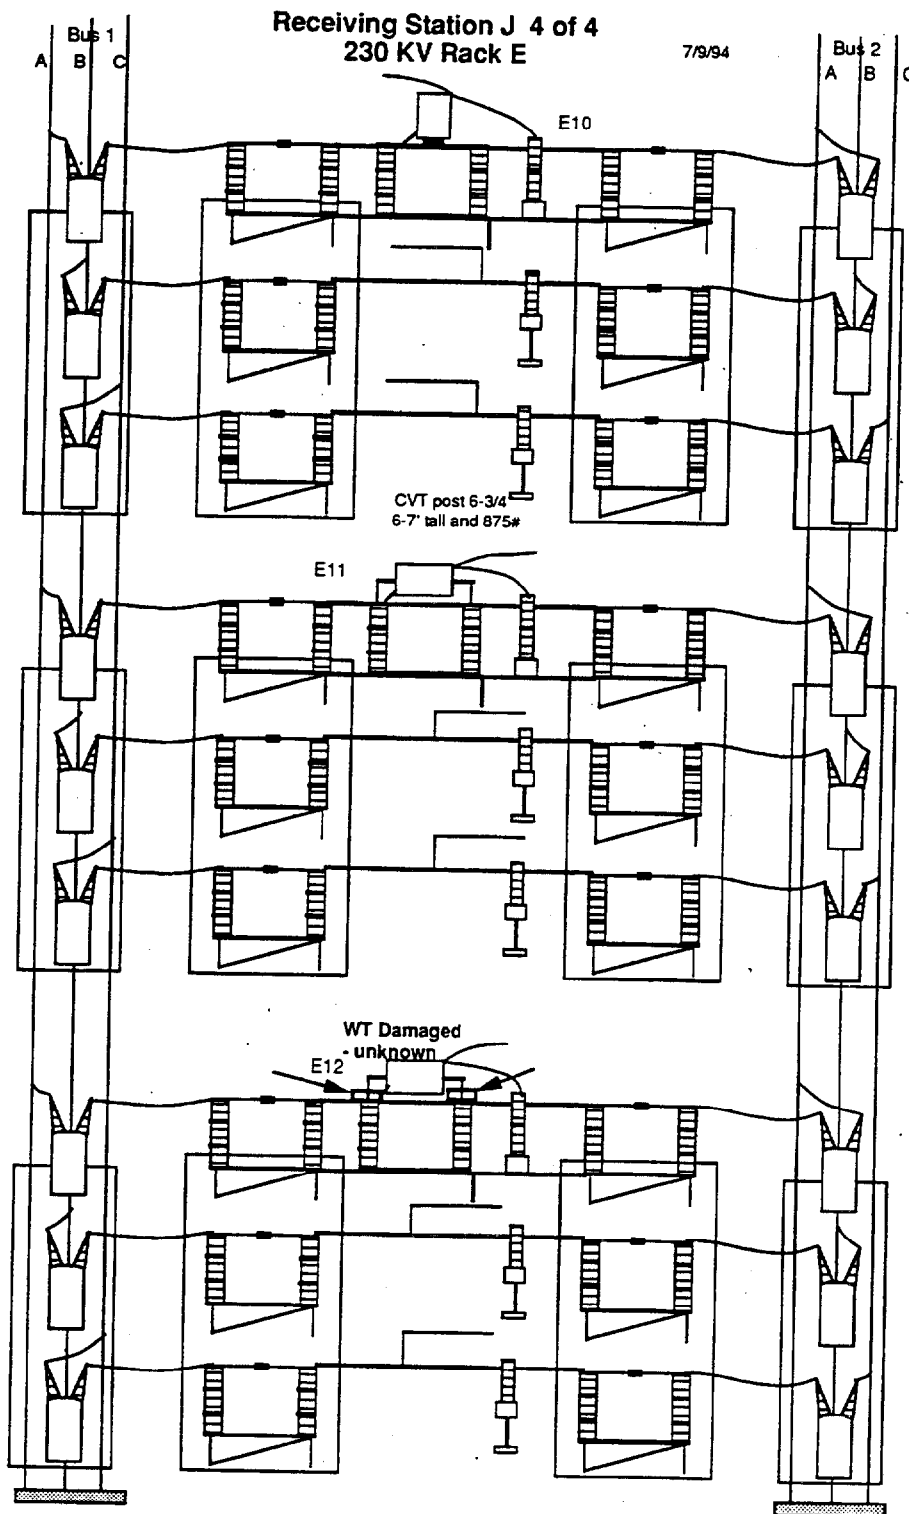
Fig. 3.53 Schematic diagram showing damage to 230 kV switchyard at Receiving Station J - Part 1.

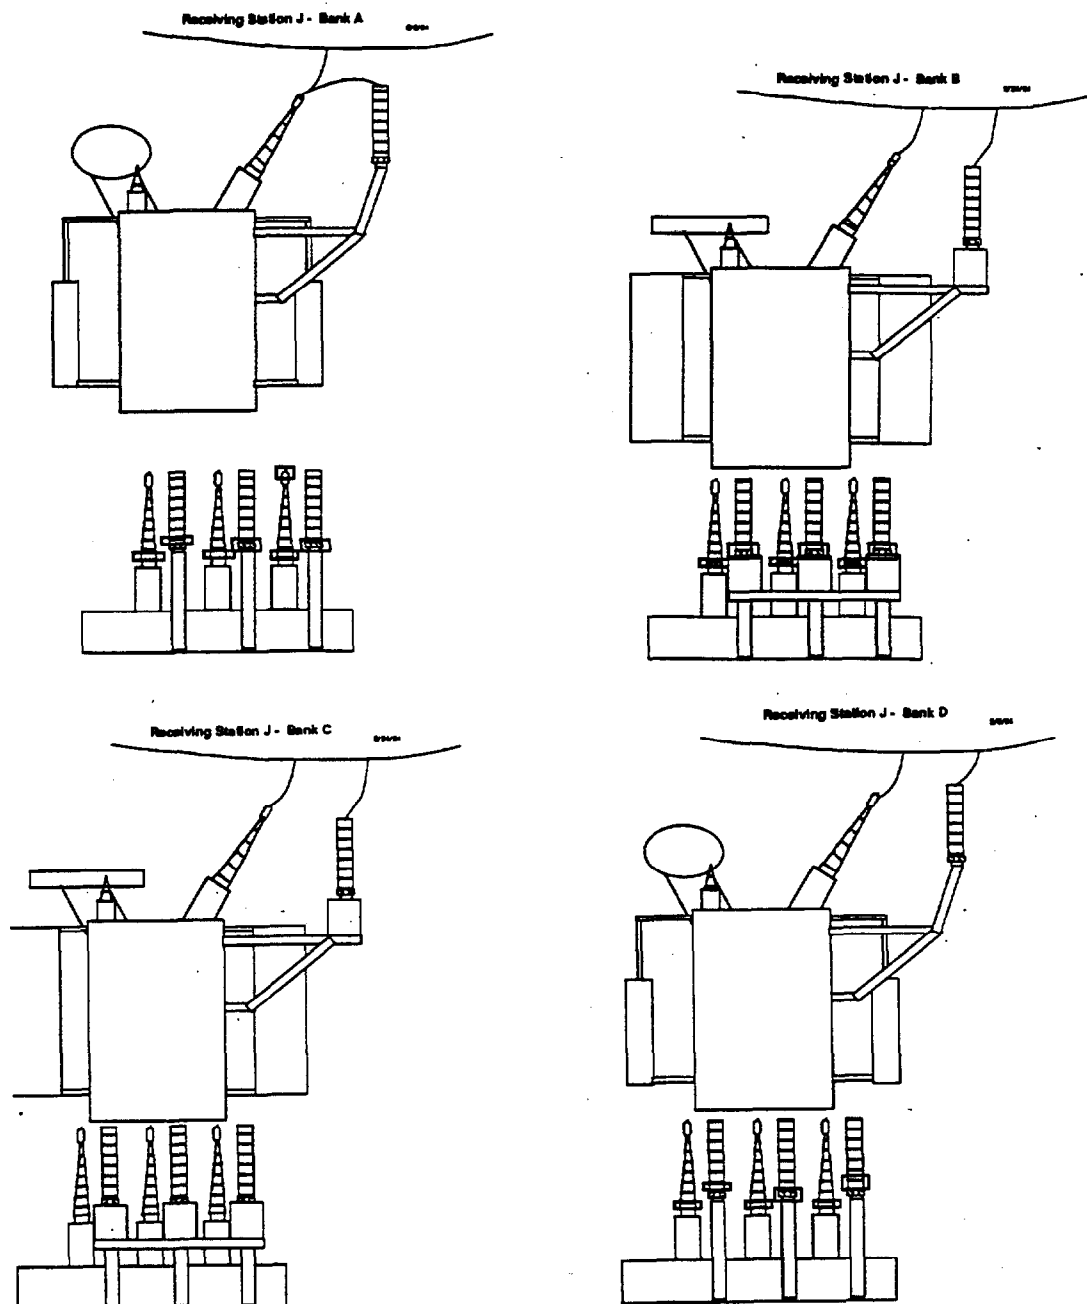
Item	Not Damaged	Damaged	Comment
Transformers	1	2	3-phase - 6 leaking bushings, 6 failed arresters, failed conservator support
Lightning Arrester	3	6	3-post mounted, 6 boom mounted failed - 2 at standoff, 4 at arrester

Fig.3.54 Schematic diagram showing damage to transformers at Receiving Station J.

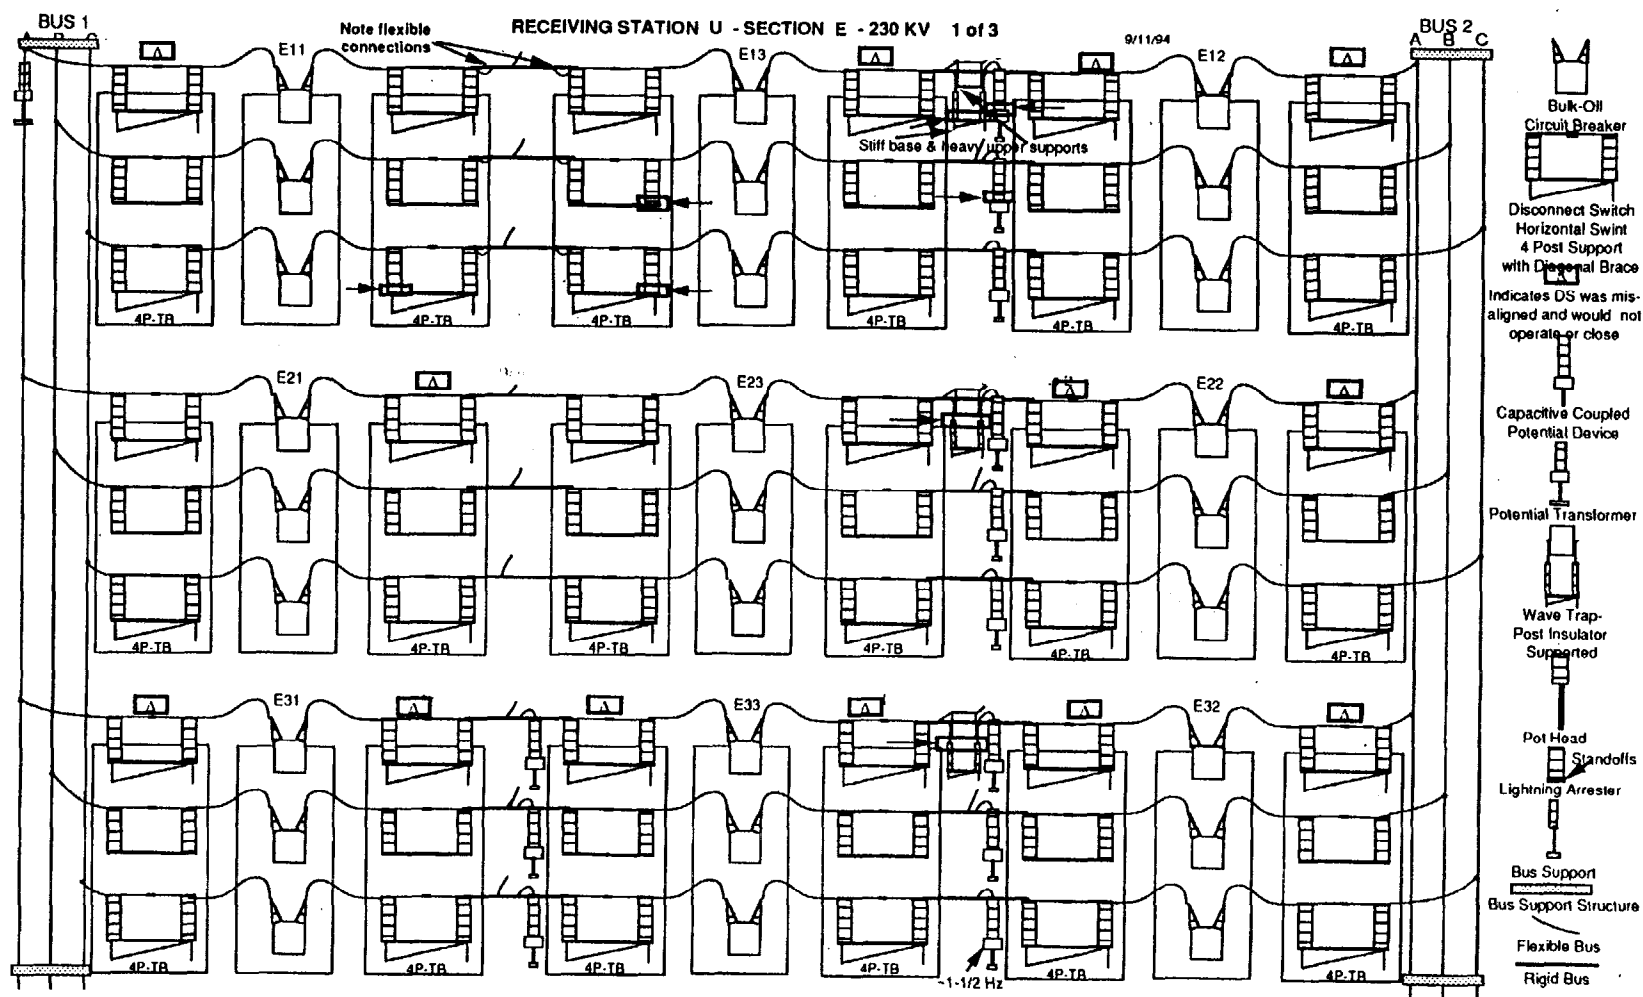
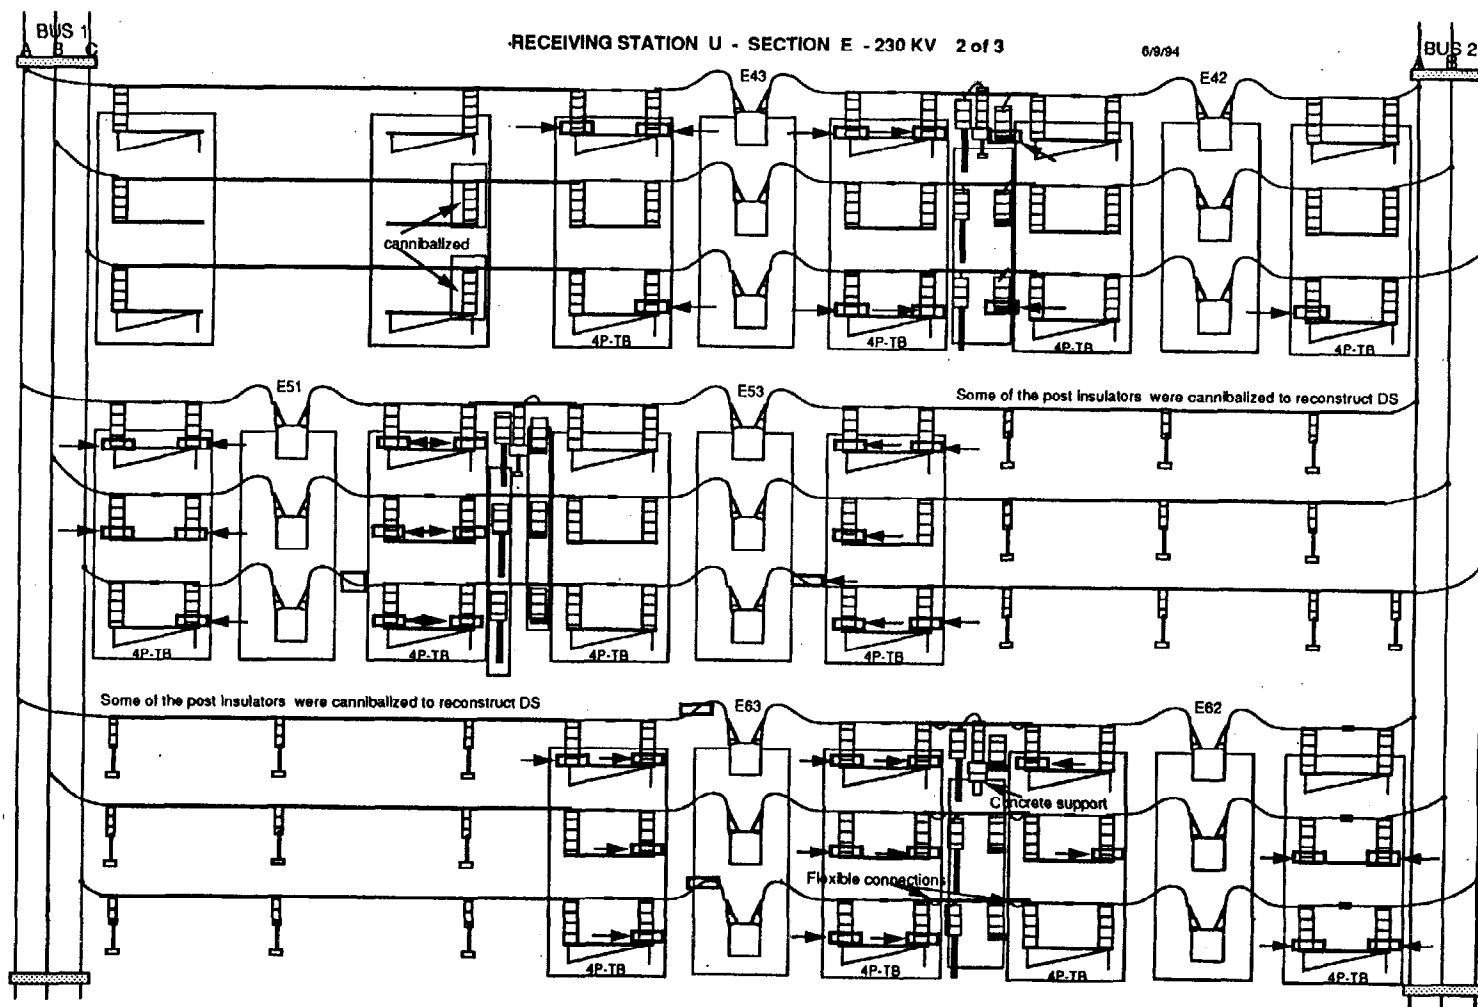
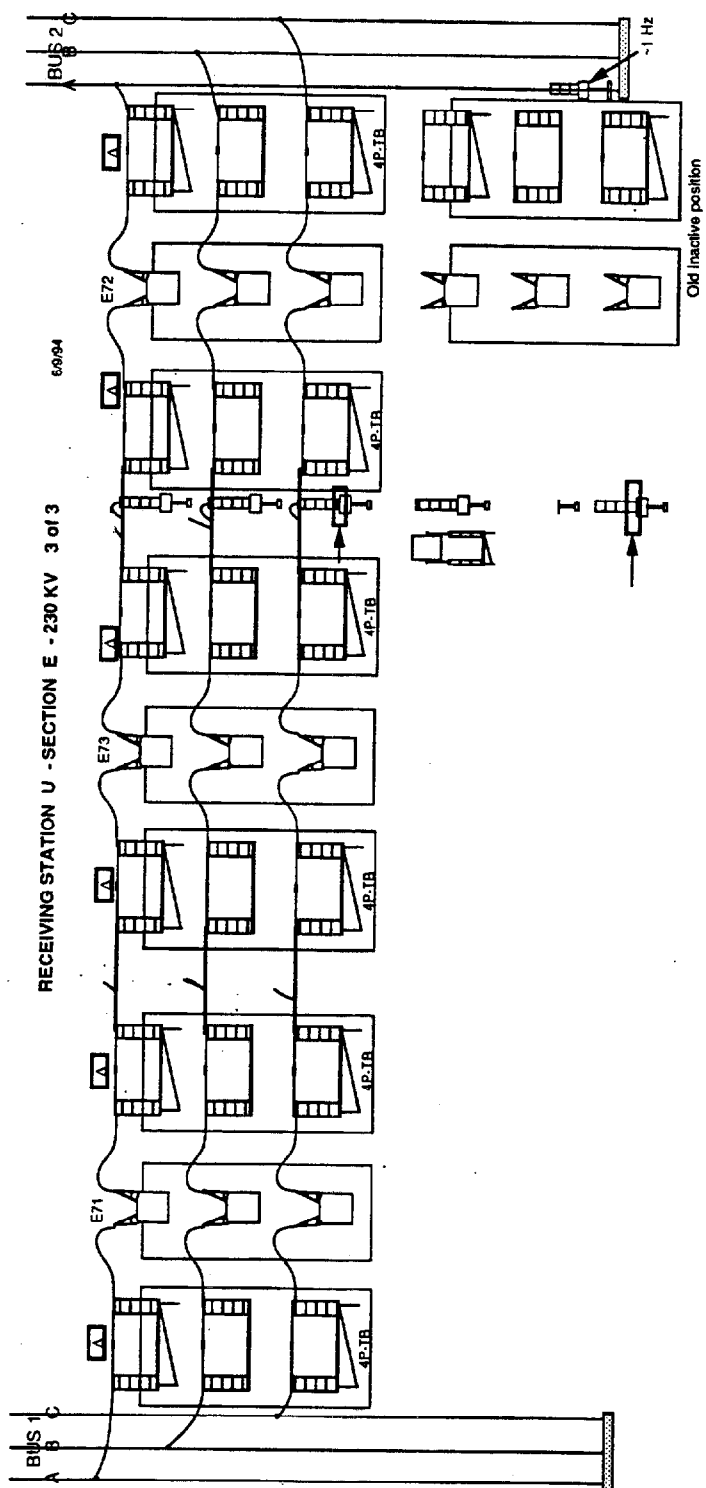
Lightning arresters, circuit switchers and a wave trap and disconnect switch were damaged. Suspended wave traps interacted with and damaged one post insulator restraint post. There was relatively little damage in the 230 kV switchyard. Figure 3.58 is a detailed schematic diagram showing damage to the 500 kV switchyards. Table 3.5 shows a summary of equipment performance.

Fig.3.55 Schematic diagram showing damage to 230 kV switchyard at Receiving Station U - Part 1.

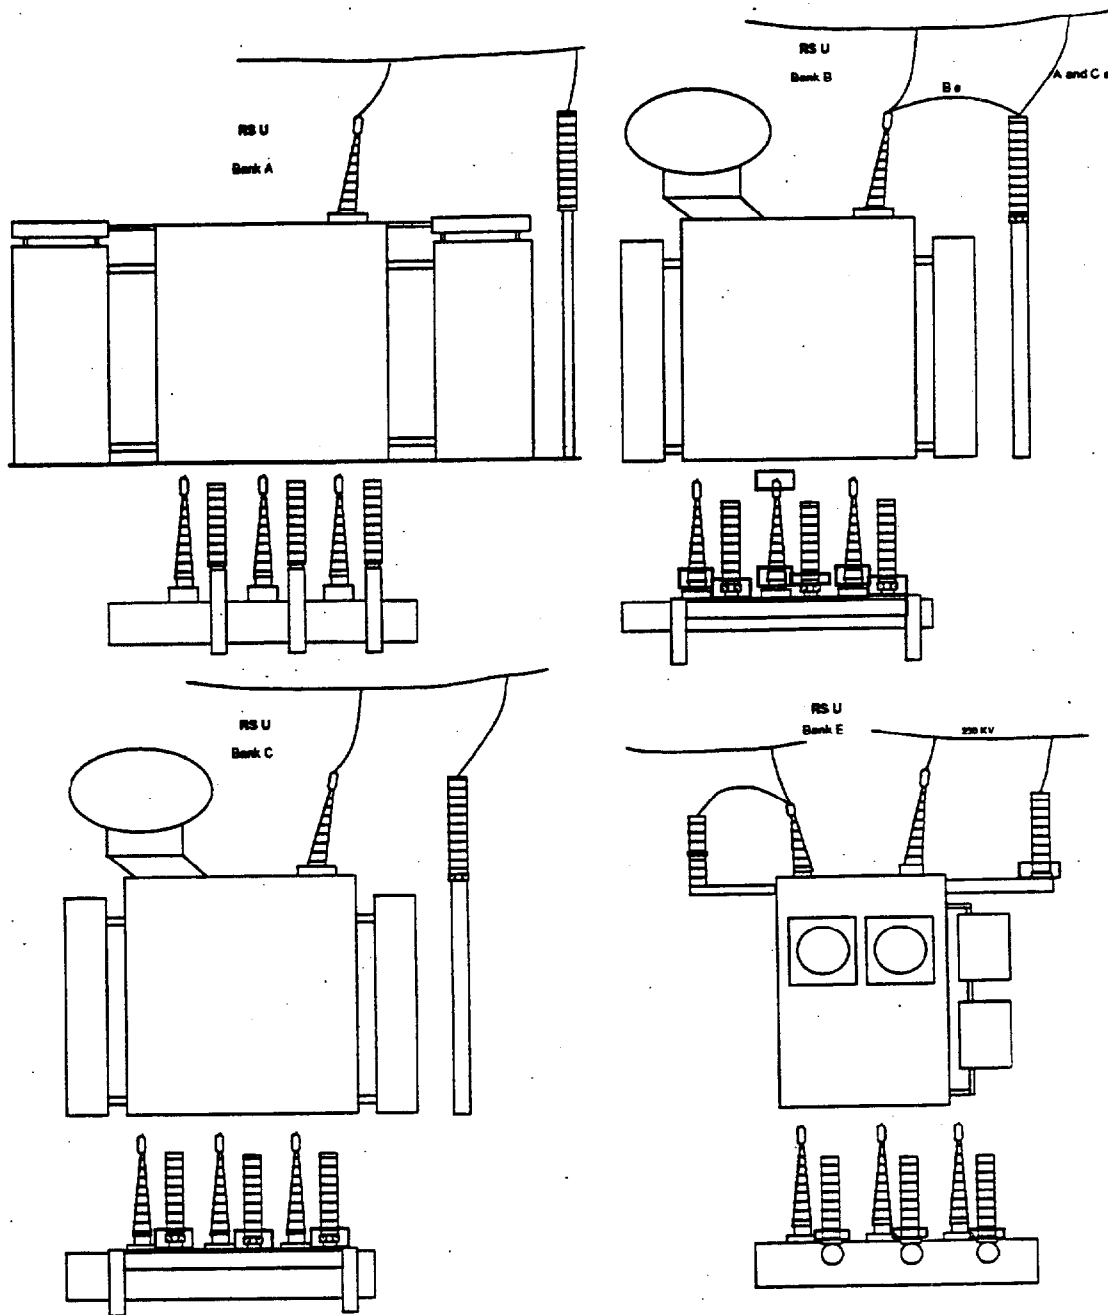
Fig.3.56 Schematic diagram showing damage to transformers at Receiving Station U.

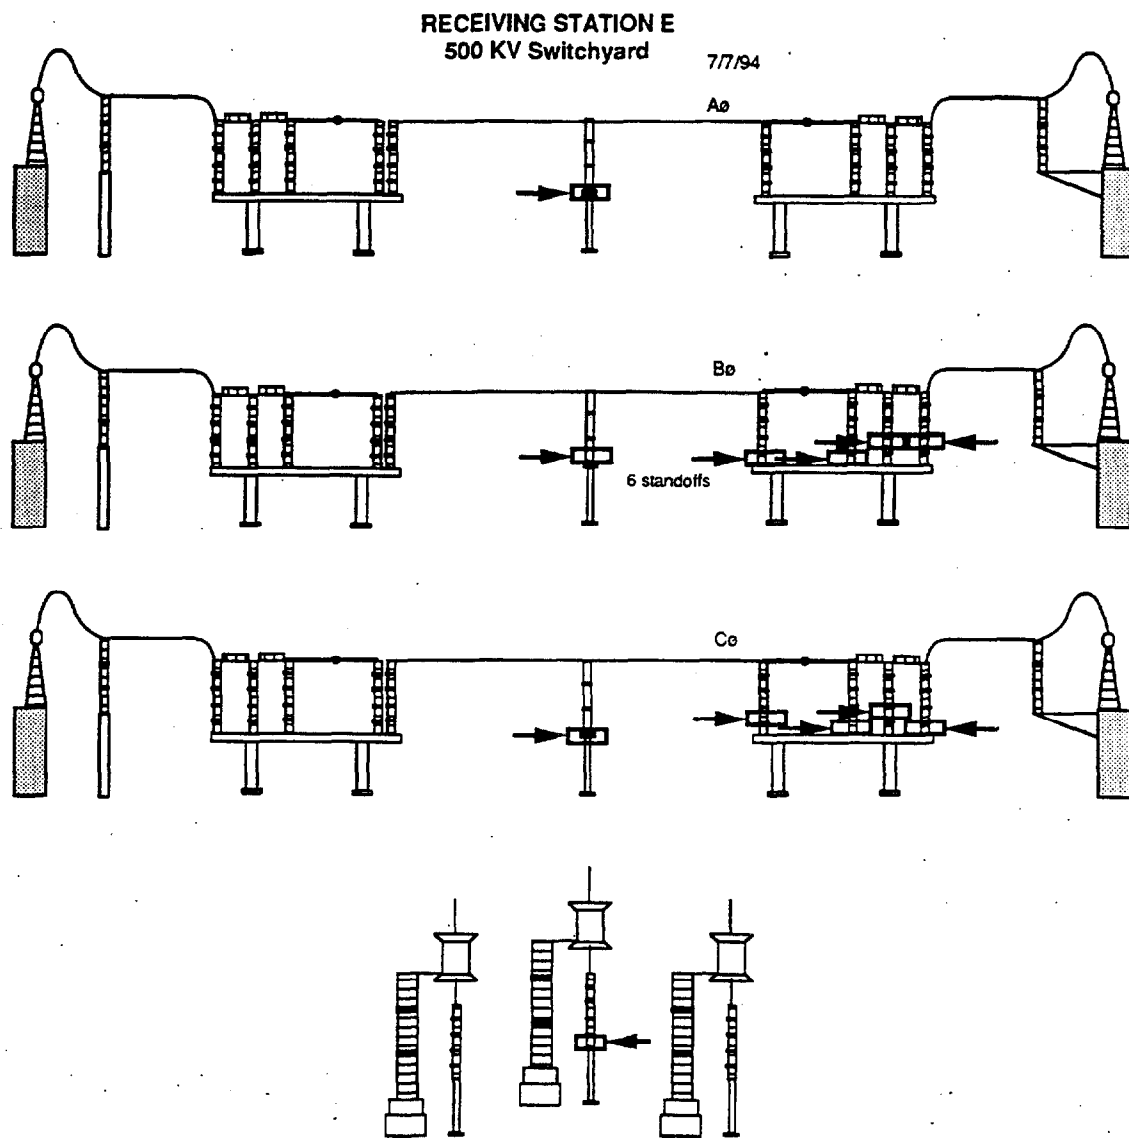
Fig.3.58 Schematic diagram showing damage to 500 kV switchyard at Receiving Station E.
